LOCALIZACIÓN DE PERFORACIONES ESC 1: 1500

Logo of ifonso s.a. and project information: CENTRO INTERNACIONAL DE CONVENCIONES DE BOGOTÁ, AUS-9973, JUNIO DE 2011.

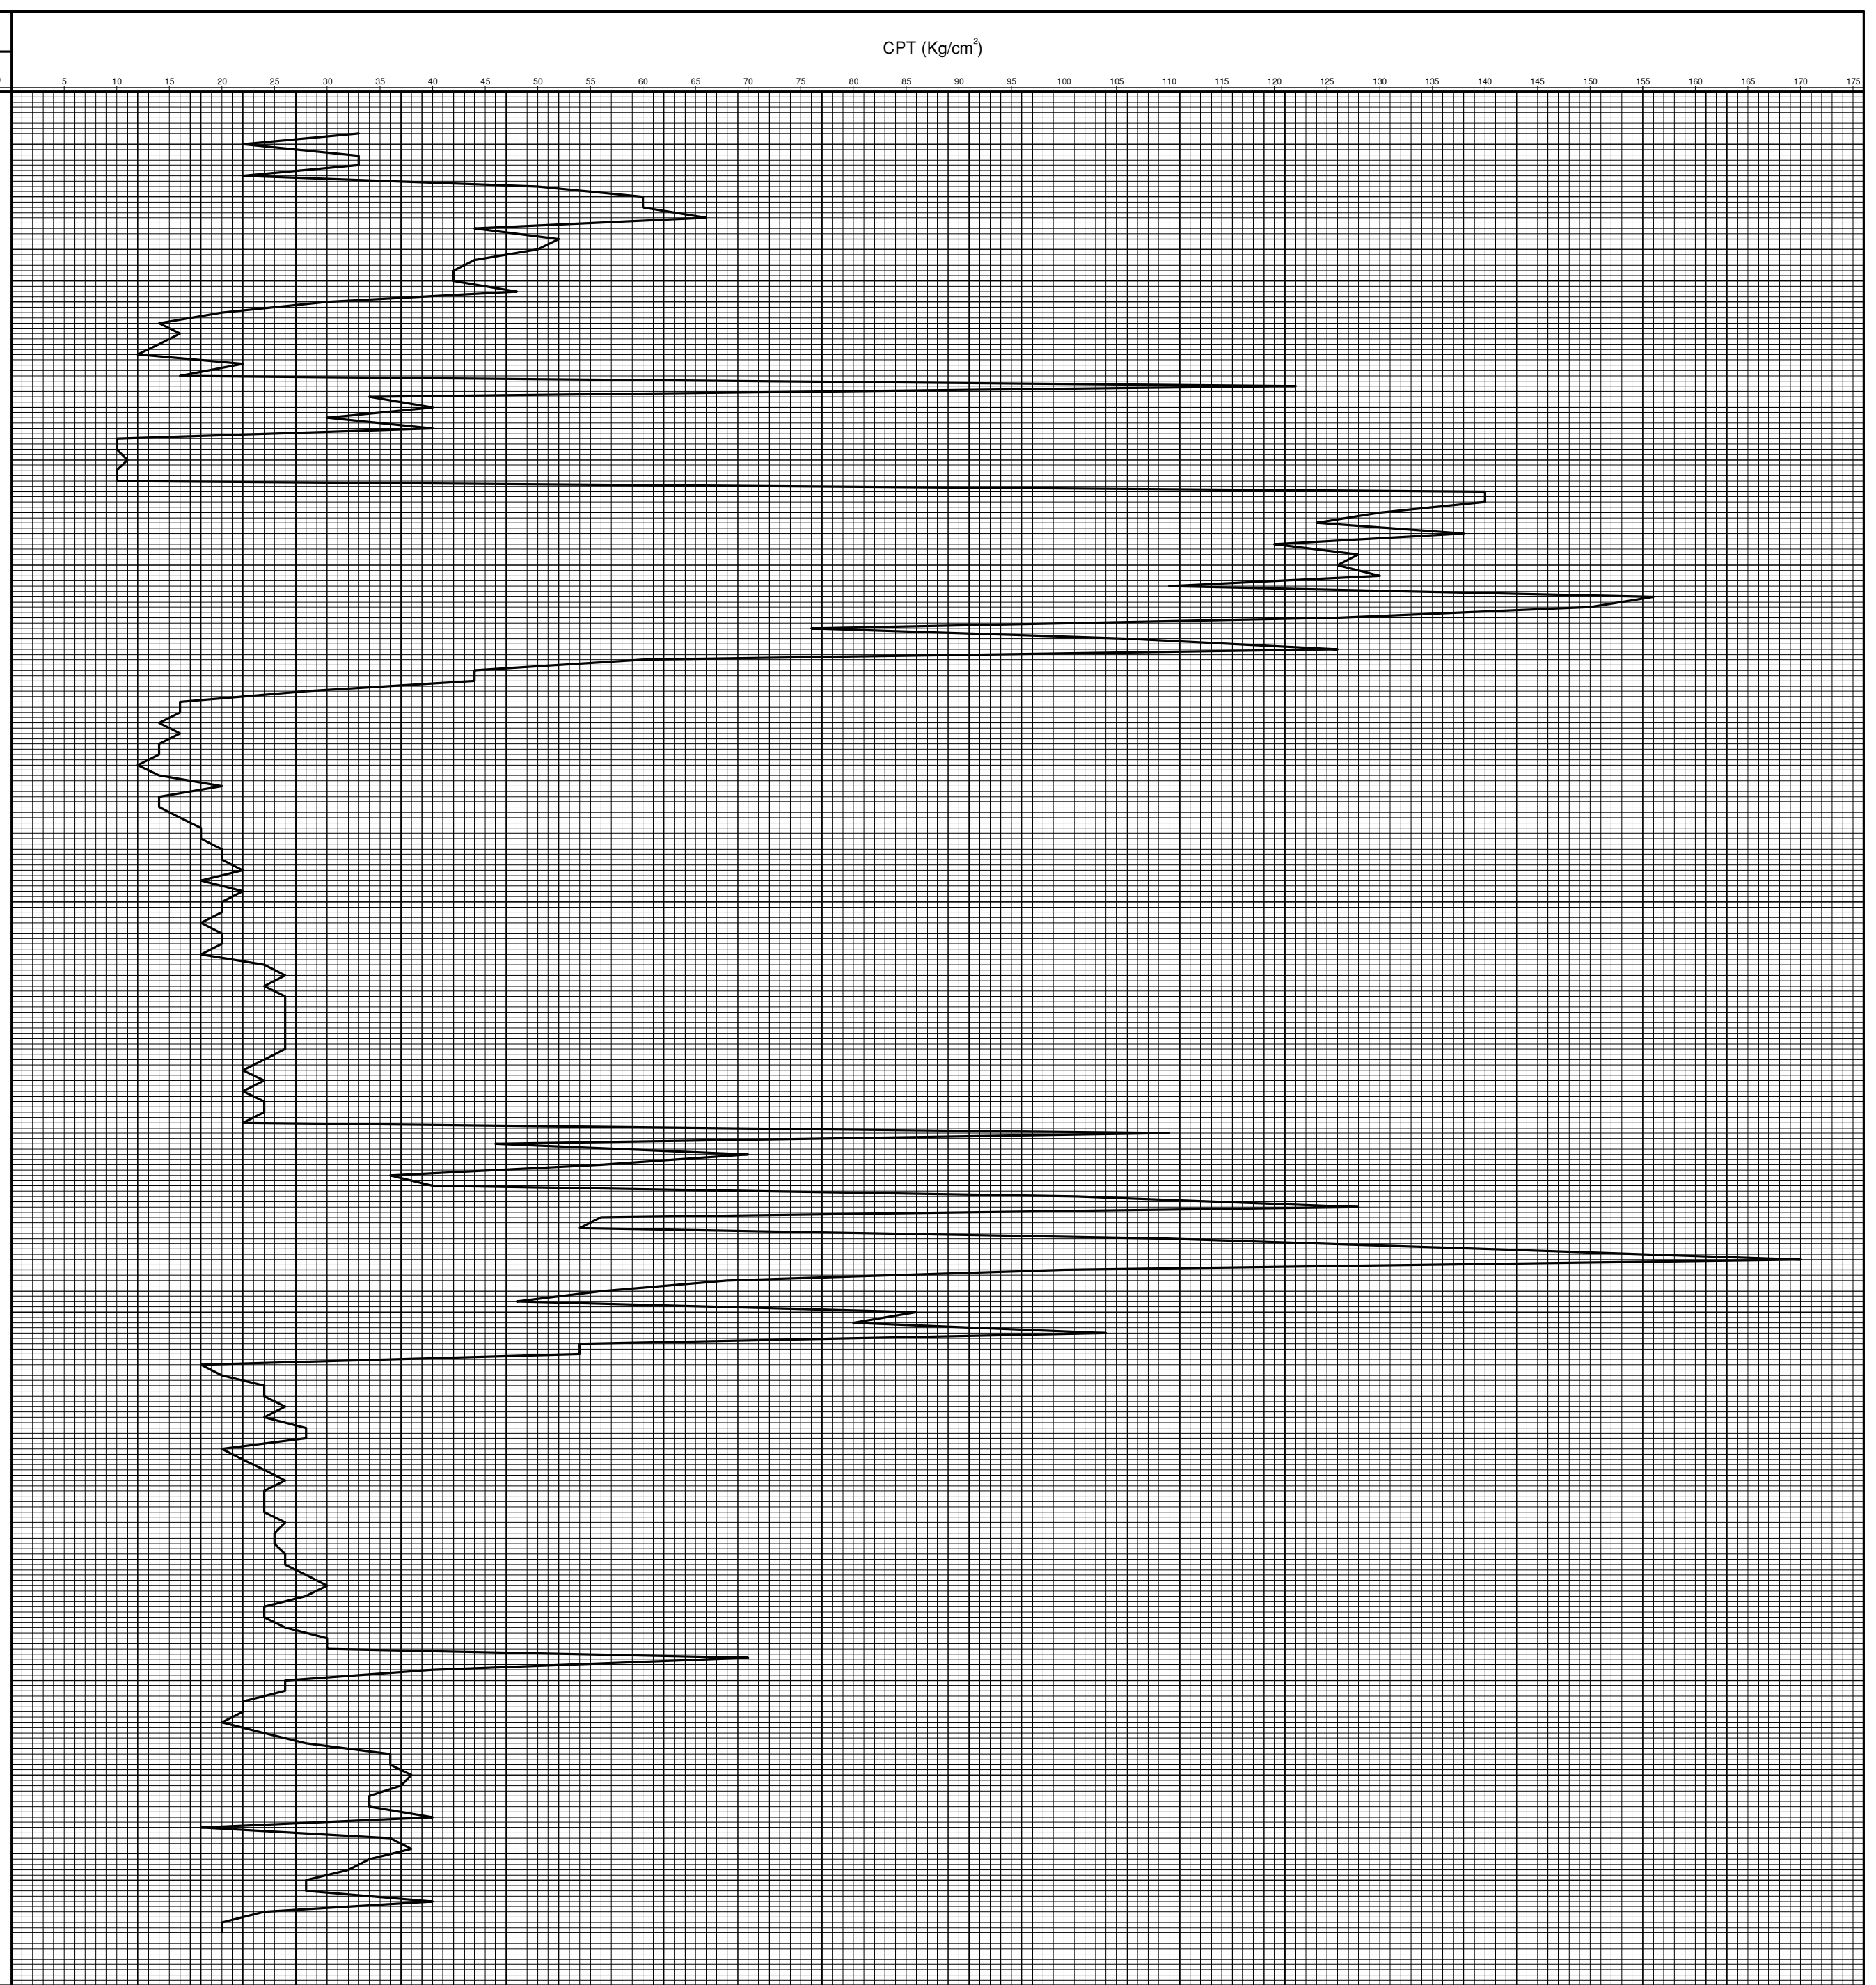
PERFORACIÓN P1: Table with columns MATERIAL, Sv, N, and depth (M, T, S). Includes materials like 'Hullido artificial' and 'Arena fina'.

PERFORACIÓN P2: Table with columns MATERIAL, Sv, N, and depth (M, T, S). Includes materials like 'Hullido en tierra' and 'Arena fina'.

PERFORACIÓN P3: Table with columns MATERIAL, Sv, N, and depth (M, T, S). Includes materials like 'Hullido en tierra' and 'Arena fina'.

PERFORACIÓN P4: Table with columns MATERIAL, Sv, N, and depth (M, T, S). Includes materials like 'Hullido en tierra' and 'Arena fina'.
